## Report Summary

Client(s): **Jesse and Mary Homeowner**

Property address: **10 Rad Rd**

## " Residential and Structural Pest Inspection Report "

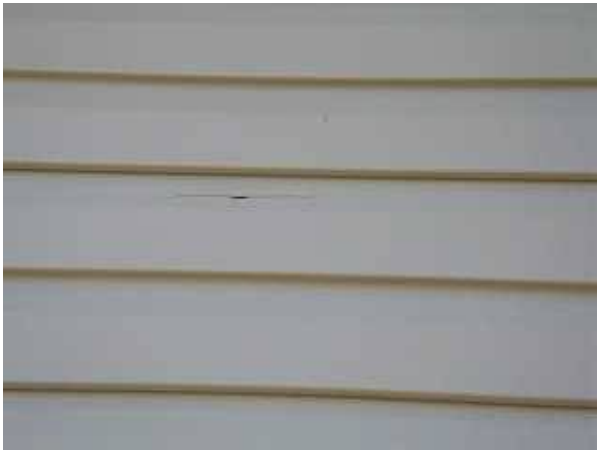
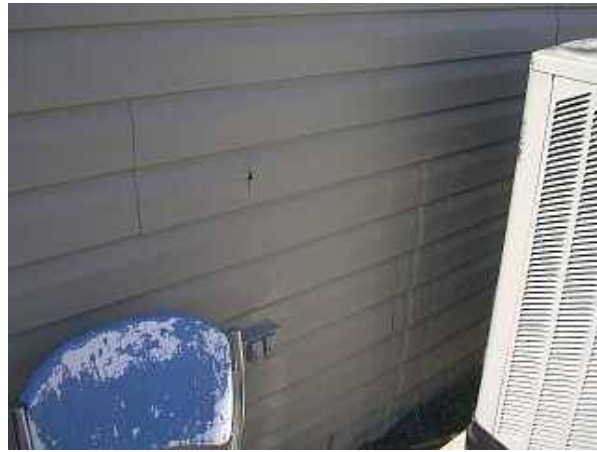
7) *Evaluate/repairs* , *Conducive conditions* - Vinyl siding is damaged and buckling in one or more areas. A qualified contractor should evaluate and make repairs and/or replace siding as necessary to prevent water and vermin intrusion. Homeowner stated repairs are to be made and vinyl material is on site.

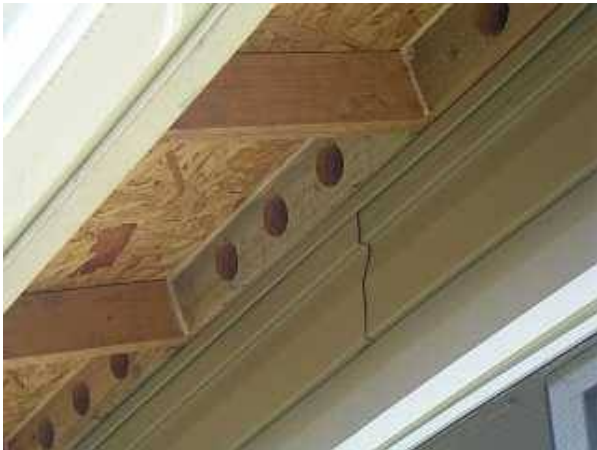
Photo 11

8) *Evaluate/repairs*, *Conducive conditions* - The exterior (paint) finish is missing on soffits. A qualified contractor should prep (pressure wash, scrape, sand, prime caulk, etc.) and paint as needed and as per standard building practices.

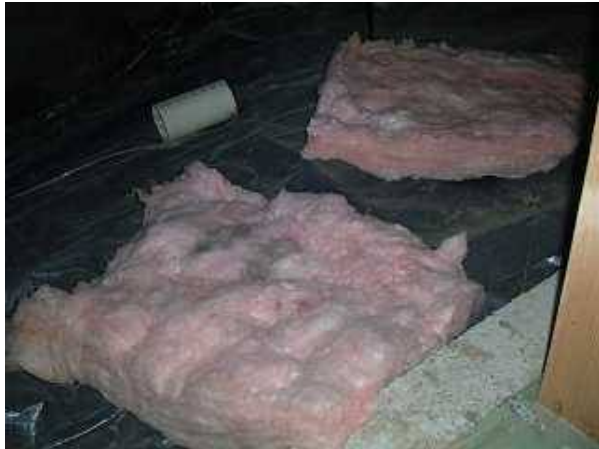
36) *Repair/Replace* - These (Summary) concerns noted in crawlspace/ unfinished basement of home and recommend addressing ASAP:

Photo 8  
insulation on grade

- (1) Bare ground in crawlspace, (vapor barrier moved.... repair)
- (2) Foundation vents partially blocked by building paper, when viewed from crawlspace. (Recommend trimming so air flows unrestricted)
- (3) Small amount of insulation batts and wood pieces in crawlspace. (Recommend removal.)

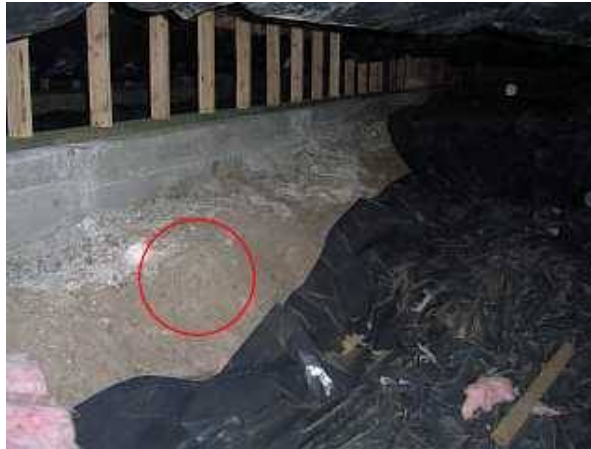
Photo 9  
bare earth, vapor barrier moved

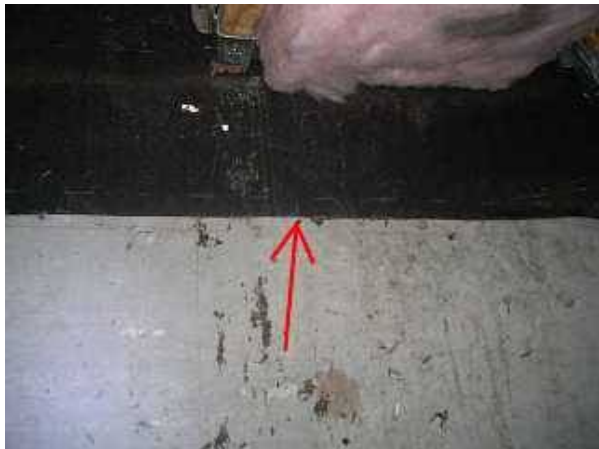
Photo 10  
Tar paper covering vents at perimeter.

(2) Foundation vents partially blocked by building paper, when viewed from crawlspace. Recommend trimming so air flows unrestricted.

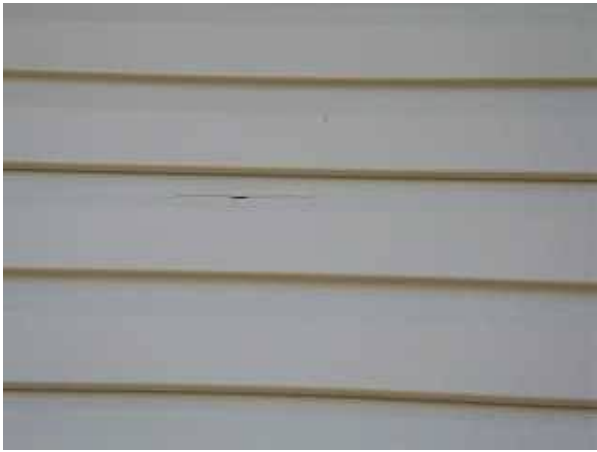
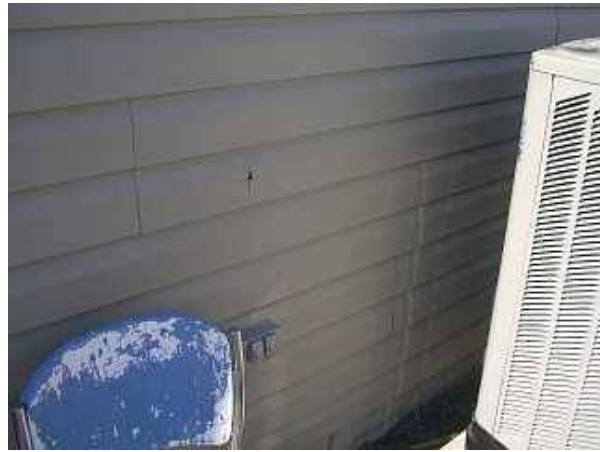
7) *Evaluate/repairs*, *Conducive conditions* - Vinyl siding is damaged and buckling in one or more areas. A qualified contractor should evaluate and make repairs and/or replace siding as necessary to prevent water and vermin intrusion. Homeowner stated repairs are to be made and vinyl material is on site.

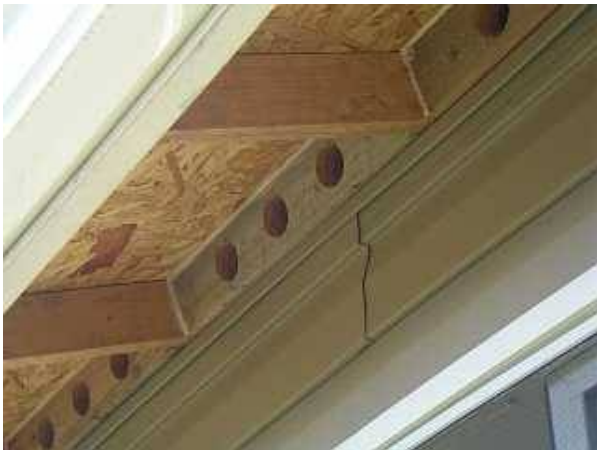
Photo 11

8) *Evaluate/repairs* , *Conducive conditions* - The exterior (paint) finish is missing on soffits. A qualified contractor should prep (pressure wash, scrape, sand, prime caulk, etc.) and paint as needed and as per standard building practices.

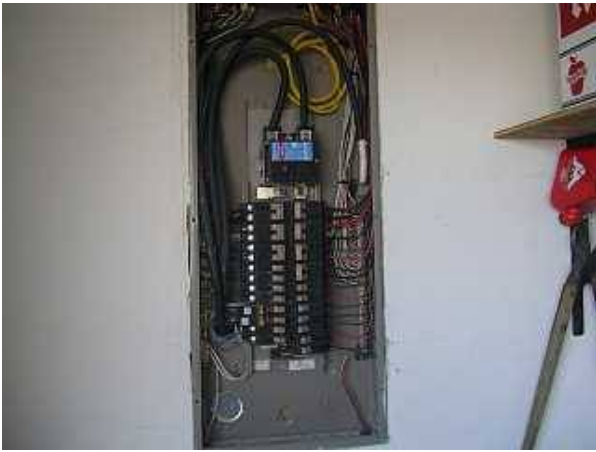
Photo 3

15) *Appears Serviceable* - All AFCI and GFCI (are installed to current standards) and function as intended, interior of panel looks good, no defects identified today.  
AFCI and GFCI breakers/ GFCI receptacles can and do fail and should be 'exercised' on a yearly basis (tested by tripping and resetting)

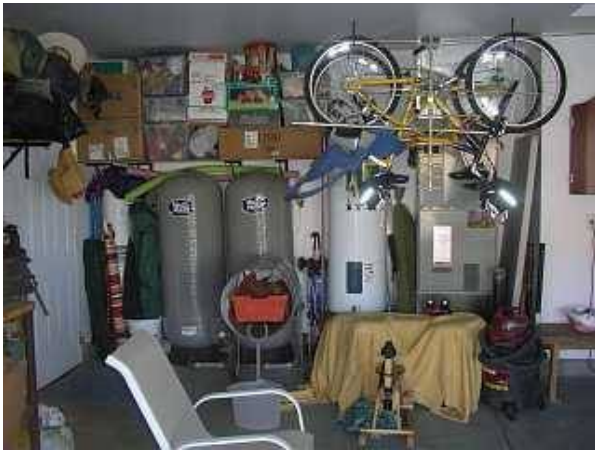
Photo 1

27) **Recommend Upgrade/ Improvement** - The water heater does not have seismic straps or struts installed. This is a potential safety hazard since movement can cause leaks in the gas supply lines or damage wiring. Leaks may also occur in water supply pipes. For safety enhancement we recommend client consider having a qualified contractor install seismic straps or struts as necessary and as per standard building practices.

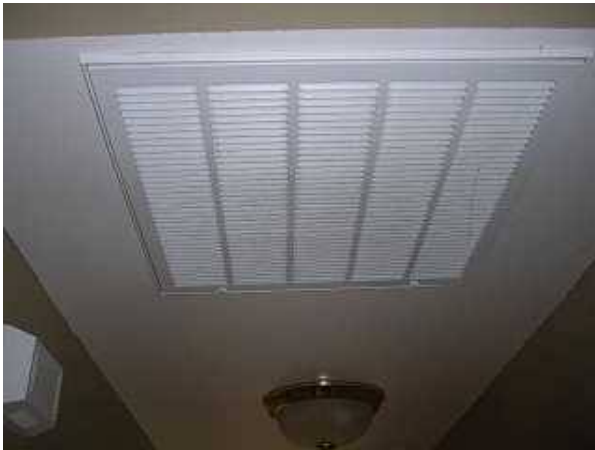
32) *Maintenance/ repairs* - Air handler filter(s) should be checked monthly in the future and replaced or washed as necessary.

Photo 7  
Filter behind grill in hall

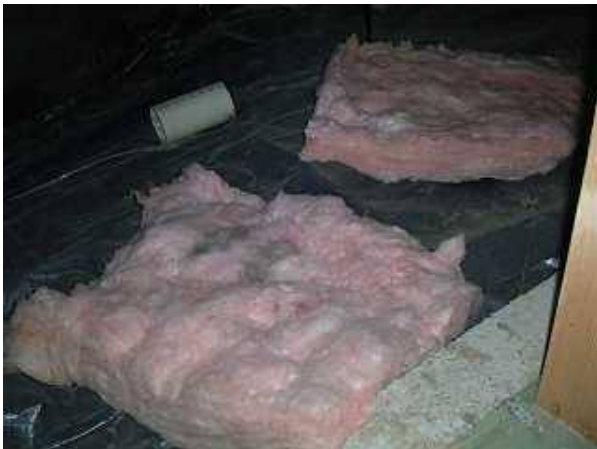
36) **Repair/Replace** - These (Summary) concerns noted in crawlspace/ unfinished basement of home and recommend addressing ASAP:

Photo 8  
insulation on grade

- (1) Bare ground in crawlspace, (vapor barrier moved.... repair)
- (2) Foundation vents partially blocked by building paper, when viewed from crawlspace. (Recommend trimming so air flows unrestricted)
- (3) Small amount of insulation batts and wood pieces in crawlspace. (Recommend removal.)

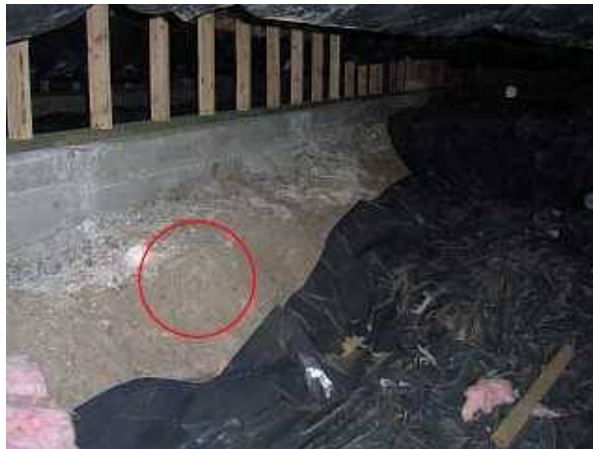
Photo 9  
bare earth, vapor barrier moved

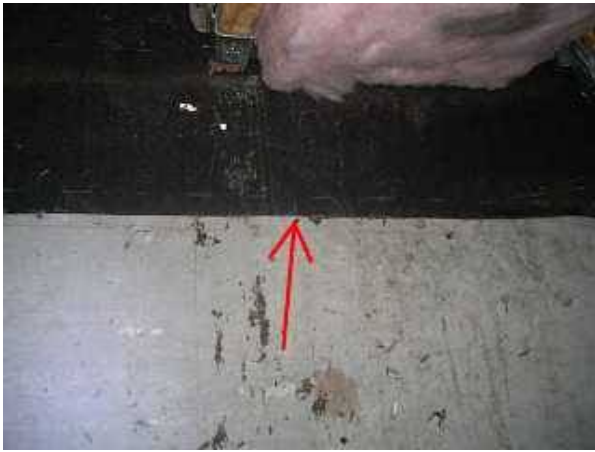
Photo 10  
Tar paper covering vents at perimeter.

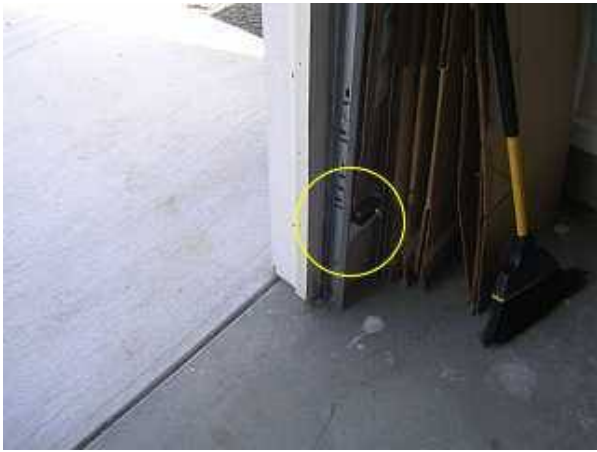
38) *Maintenance/ repairs* - The infrared "photo eye" devices that trigger the vehicle door opener's auto-reverse feature are located higher than 4 to 6 inches from the floor. This is a potential safety hazard. A qualified contractor should relocate these devices so they're 4 to 6 inches from the floor.

Photo 6  
 Recommend lowering to 4-6" for safety

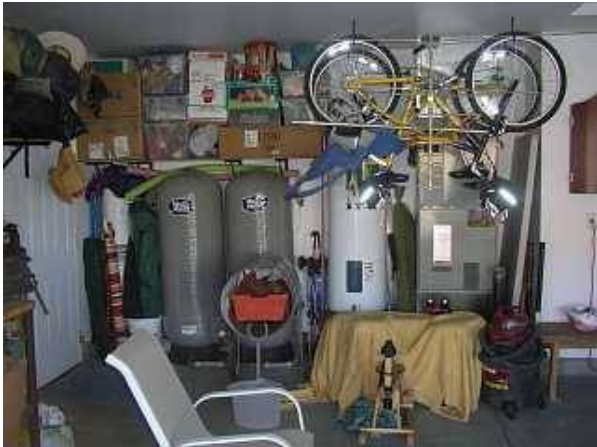
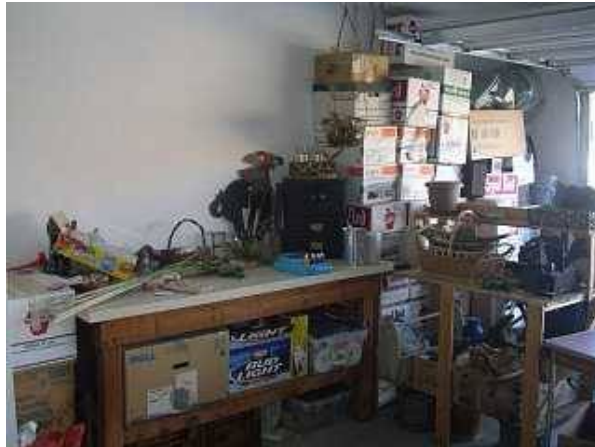
40) *FYI* - The interior perimeter of the garage is excluded from this inspection due to lack of access from stored items.
